Limited Visual Dam Safety Inspection Summary Report

MA-141

Wailuku Project District Retention Basin

Limited Visual Dam Safety Inspection Conducted on: 03 April 2006

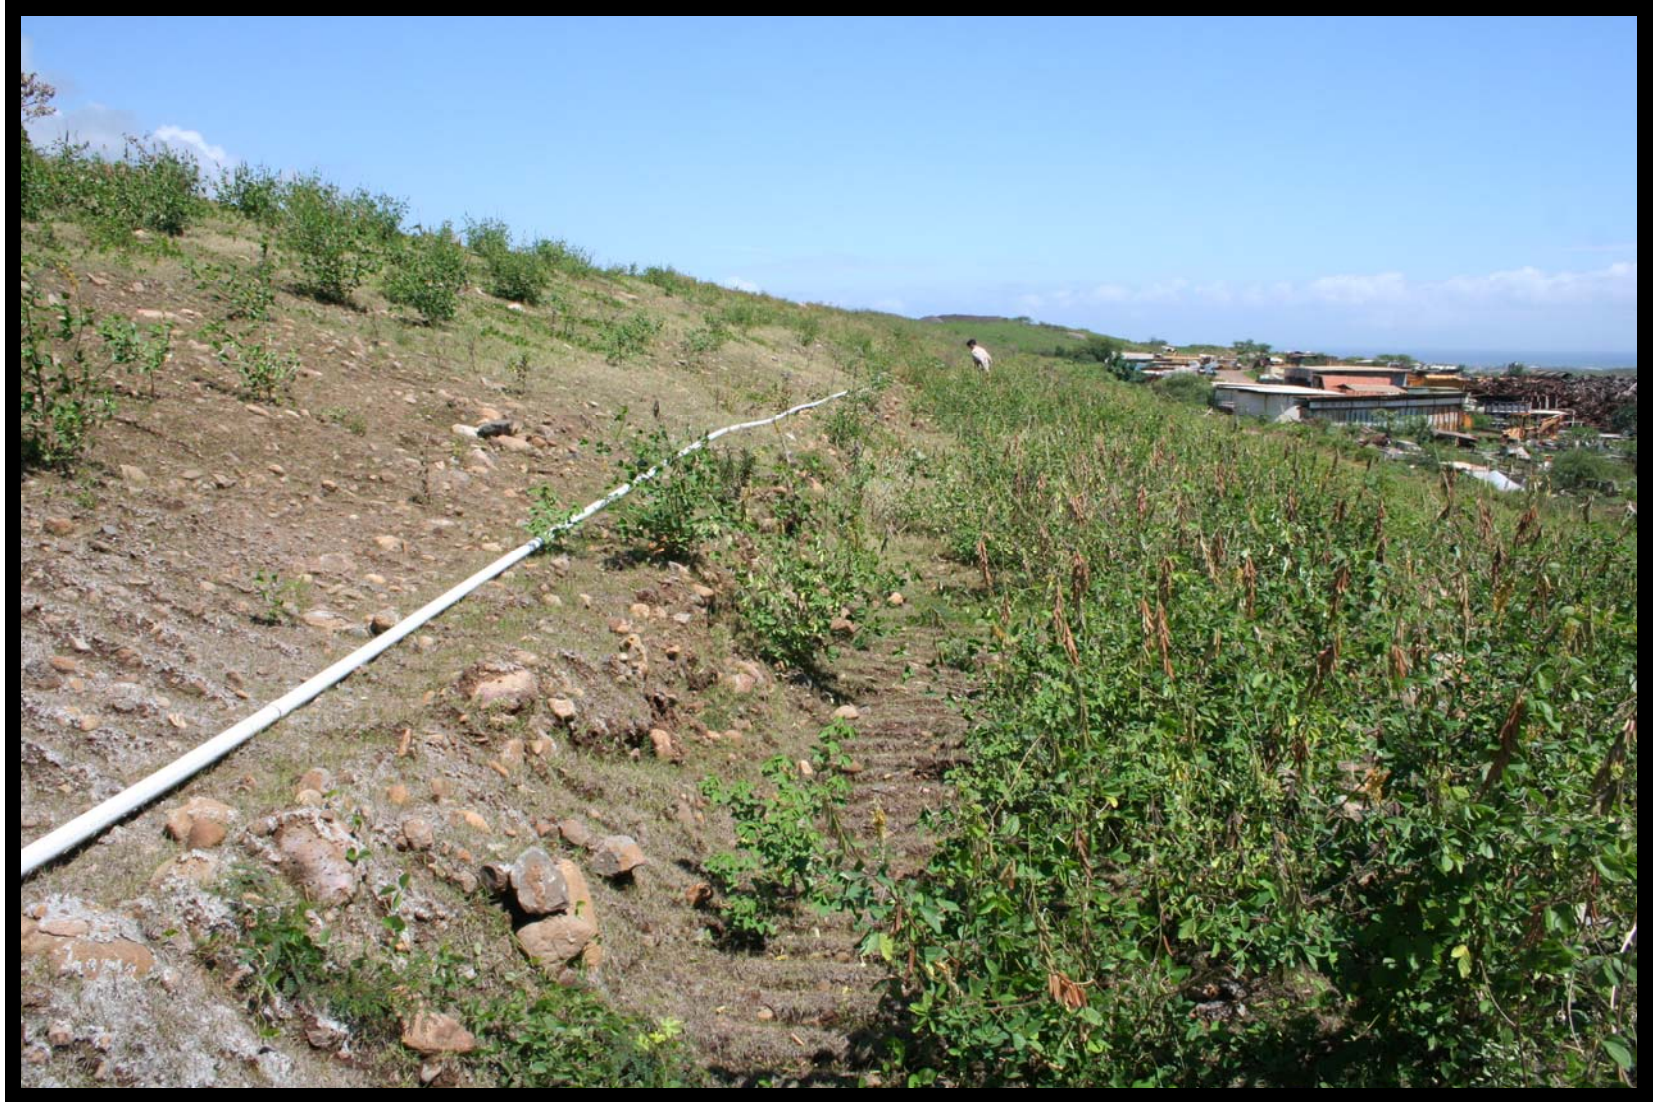
141 east side grass and uneven - Midslope sparse grass and uneven berm on east embankment

- ☐ e. Slope protection needs maintenance or repair. Description: _____
- ☒ f. Rut and/or Gully erosion was observed on the slope, which requires maintenance and/or repair.
Description: East embankment requires turf improvement and minor grading.

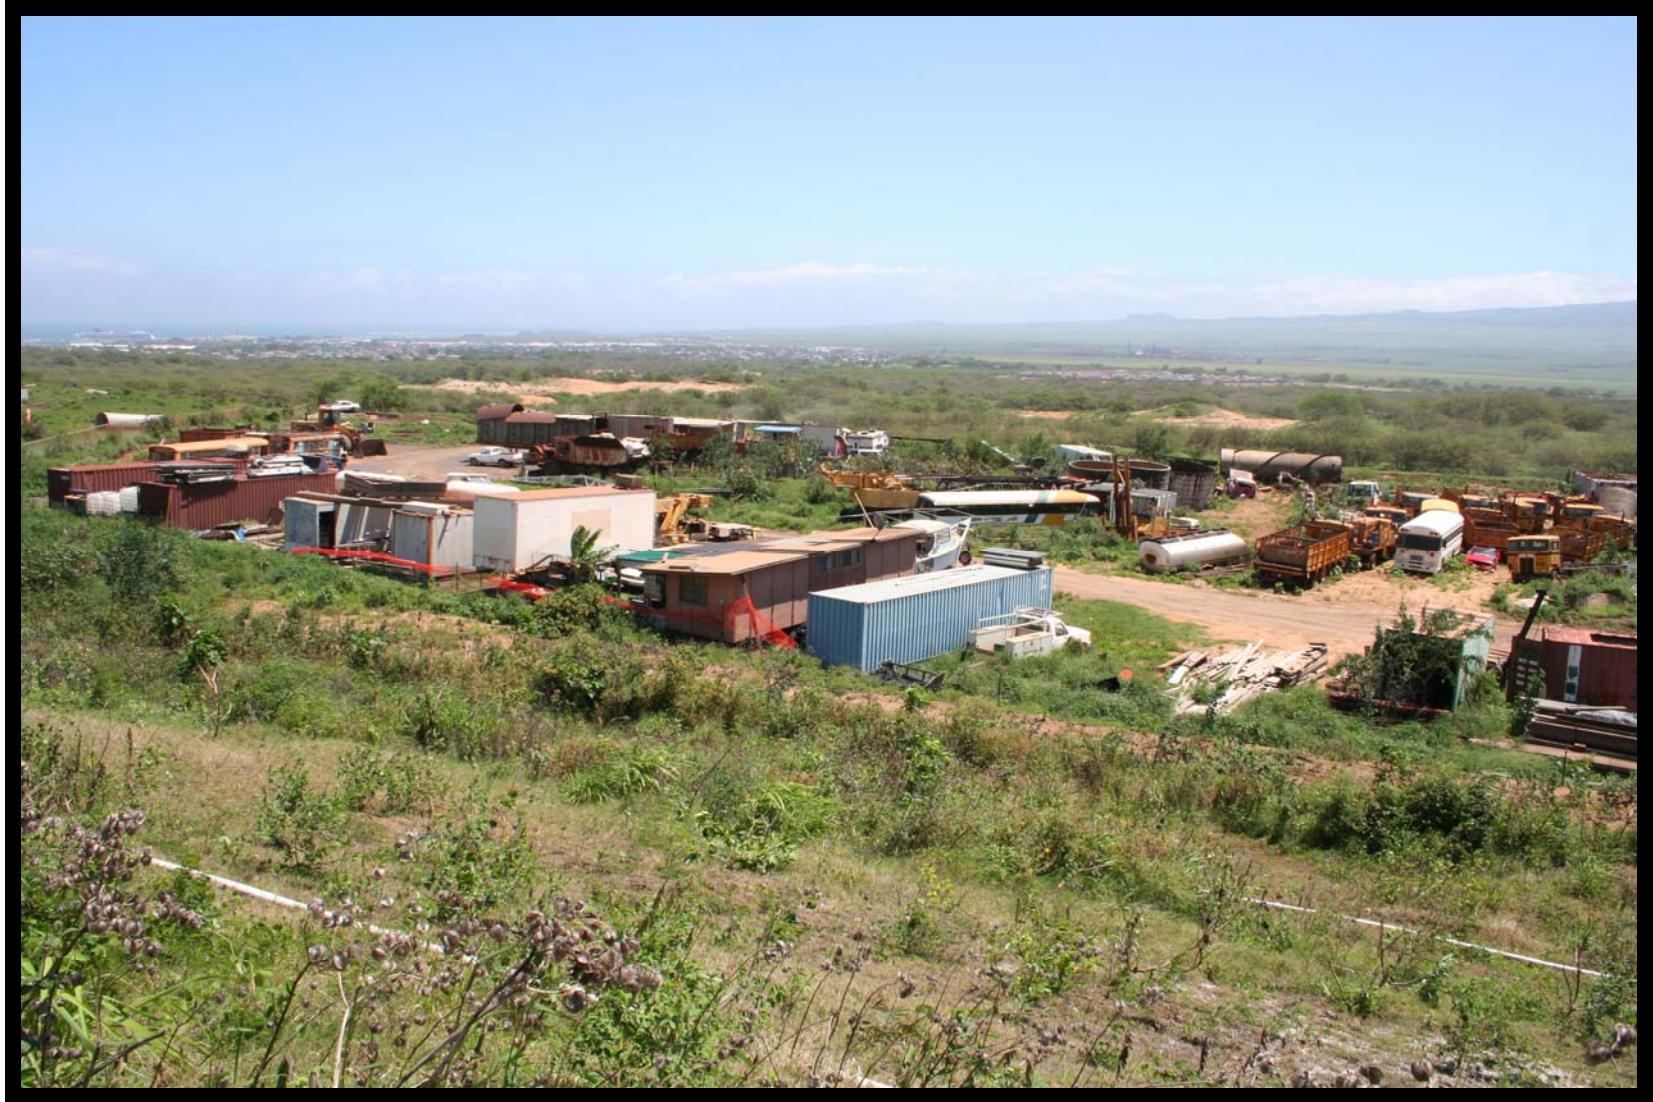
141 east resident in brown trailer - Transient residents
downstream of east embankment

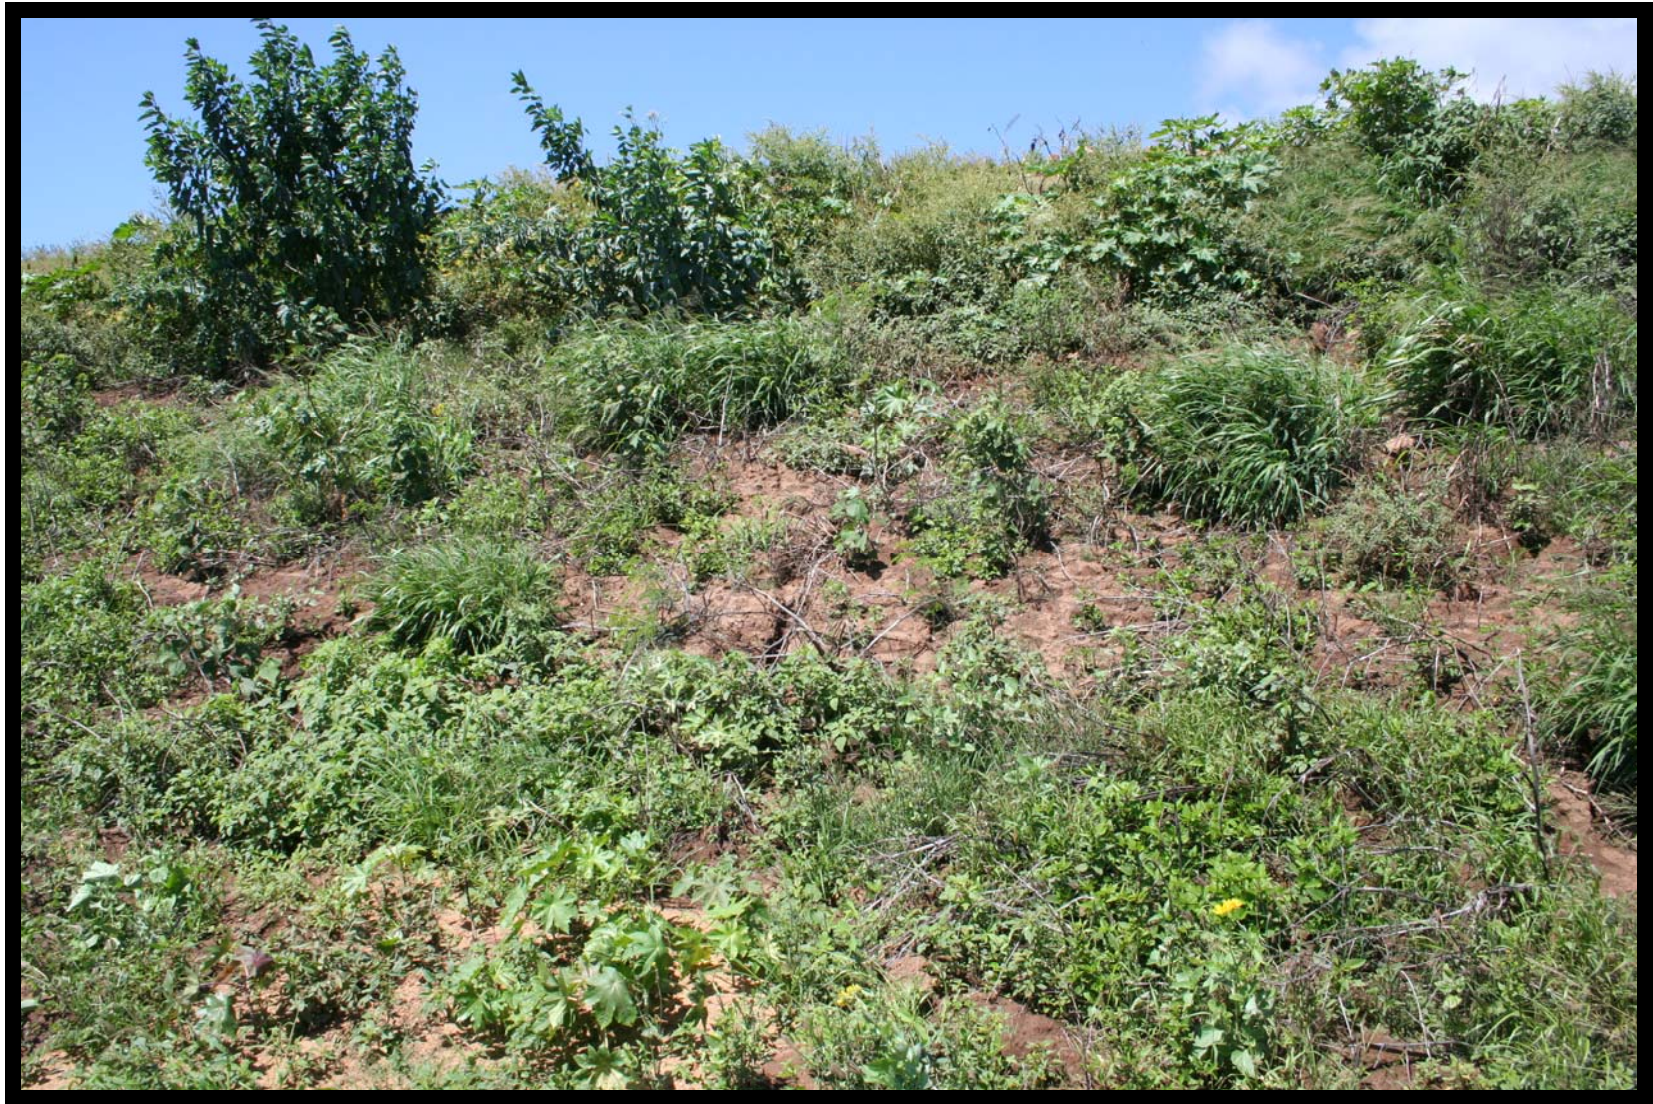
141 east embankment erosion - Sparse grass and minor erosion on downstream side of east embankment

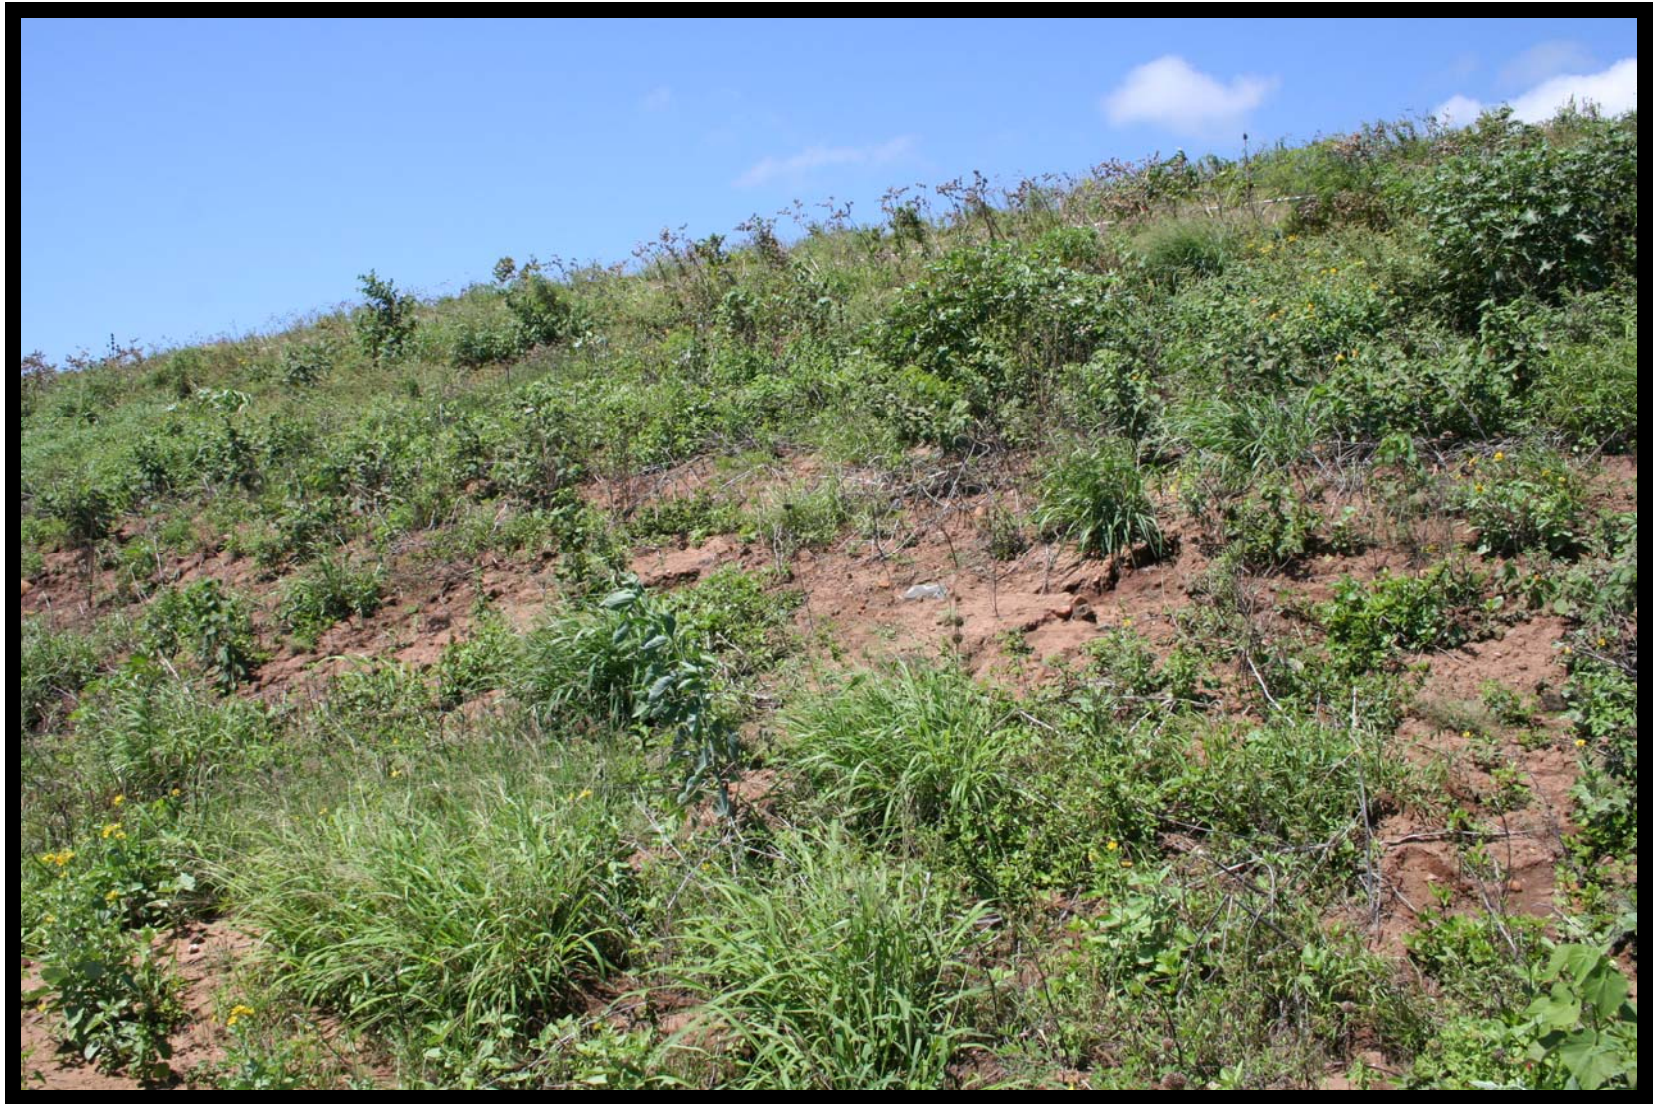
141 east embankment erosion 2 - Sparse grass and minor erosion on downstream side of east embankment

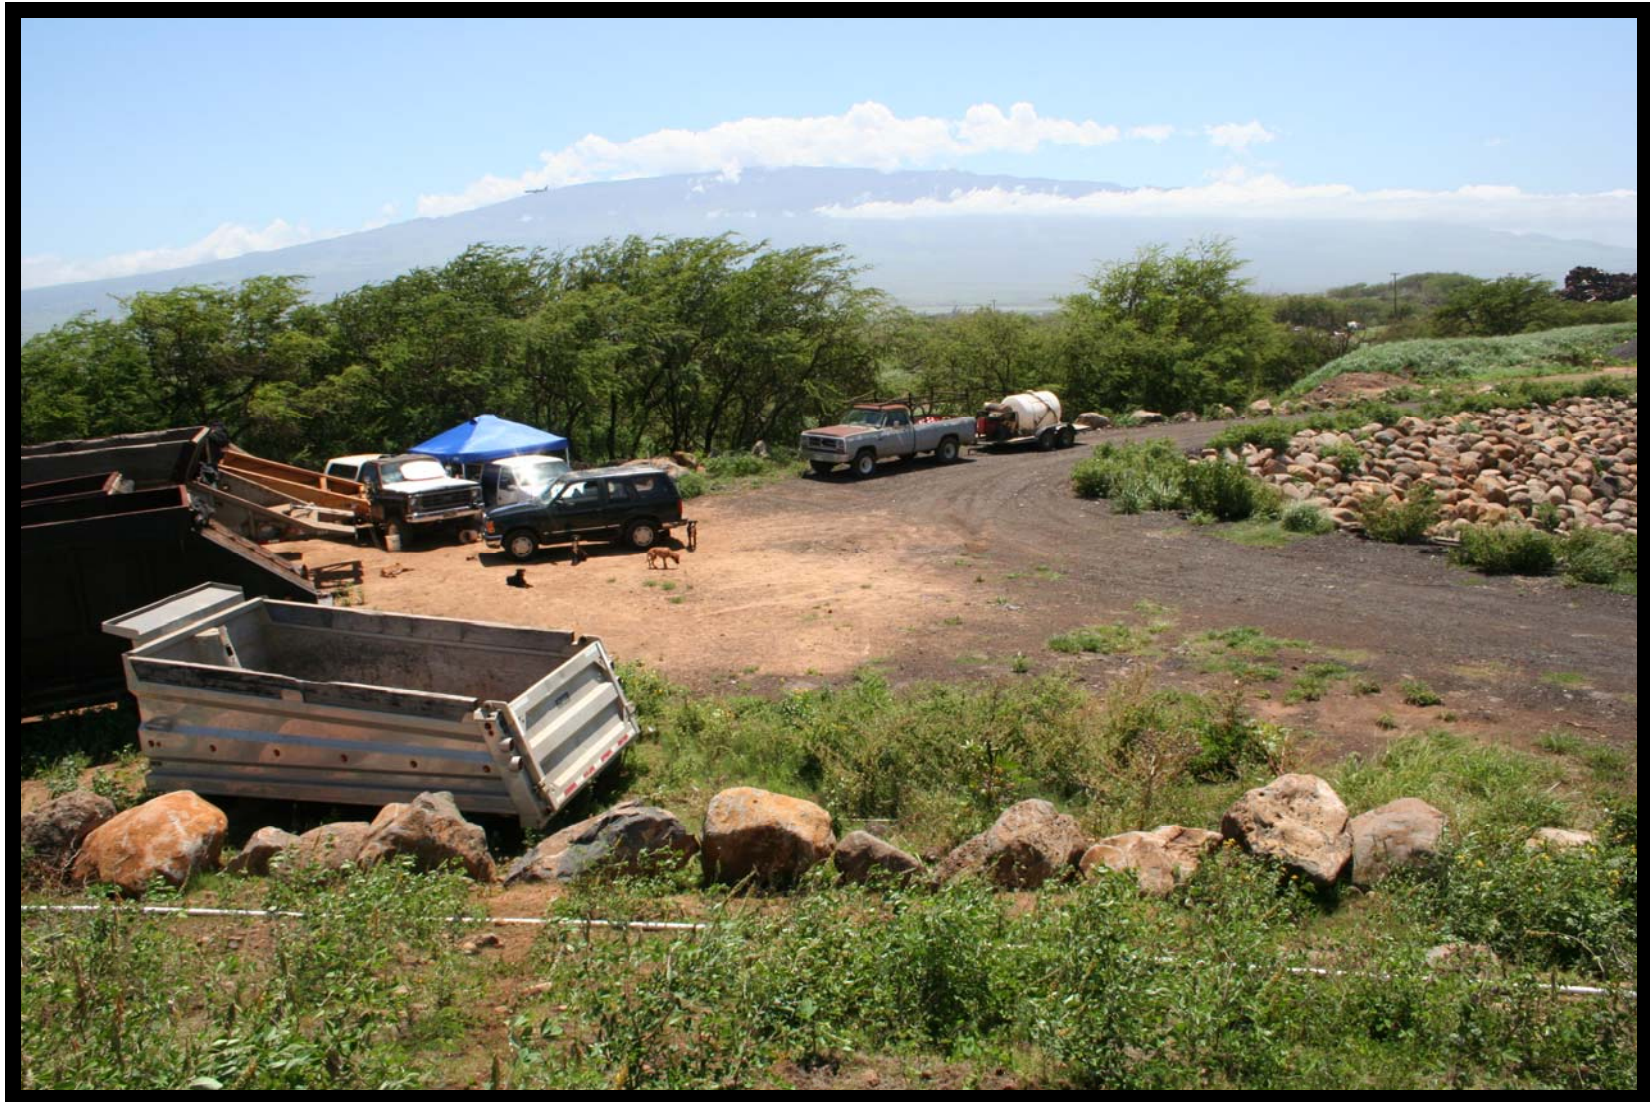
141 Downstream residents blue awning - Transient residents downstream of SE corner
